Olatz Arriaga Arruti
Dr. Luca Gnocchi

Extended Reliability of Silicon Heterojunction Solar Modules

July 1st, 2022

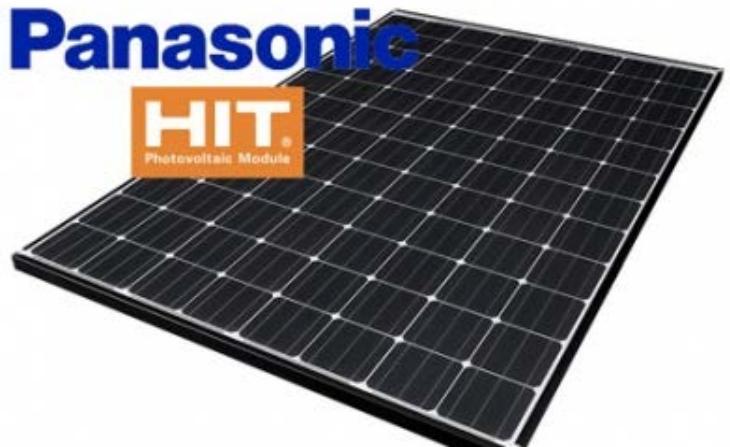
Performance Loss Rates (PLR)

All data-sets

High-accuracy data-sets

- **Literature review on long-term performance of SHJ modules:**
 - PLR values of **0.56 %/year** for all data-sets and 0.80 %/year for high-accuracy.
 - Main failure modes: loss in **V_{oc}** and **encapsulant discoloration**.
 - Could achieve lifetimes of 35+ years if encapsulated with a reliable BOM.
- **Indoor Accelerated Stress Tests:**
 - Sensitivity of SHJ cells & modules to **moisture ingress**, high voltages (**PID**) and **UV** exposure.
 - The use of an **edge sealant** is recommended to **reduce water ingress**: a dry EVA has proven to better withstand prolonged UV exposure and to mitigate SHJ DH and potential induced degradation (PID).
